DEPARTMENT OF NATURAL RESOURCES

Minerals Inspection Report

Mine Name: Mystery	Permit Number: S/019/0034	Mine Status: Suspended
Operator Name: James W. Hill	Inspection Date: 09/17/2013	Permit Fees: Delinquent
Inspector(s): M. Bradley	Inspection Time: 2:30p	Bond Amount: \$2,000
Attendee(s): none	Weather: Clr-Pt. Cloudy	Bond Escalation:
Inspection Purpose: Routine inspection, attempt to verify location		Prior Inspection: 01/01/2008

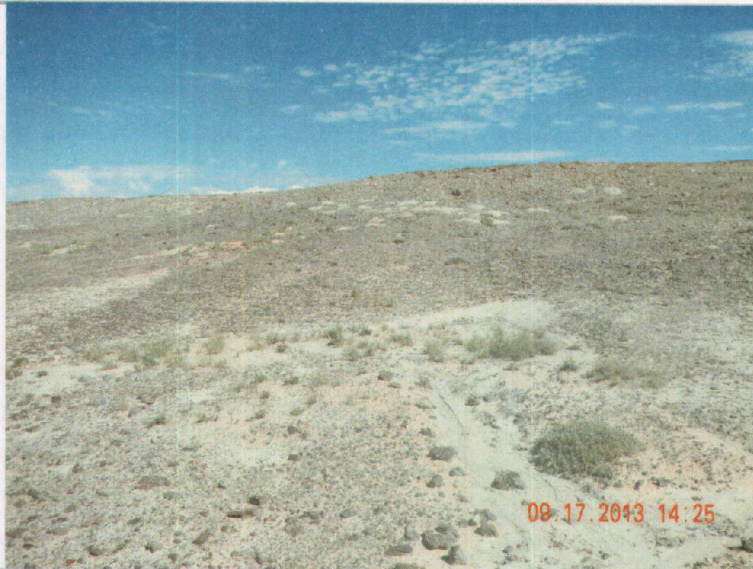
Area near Mystery Mine that was inspected. Light-colored areas in slope are hole locations

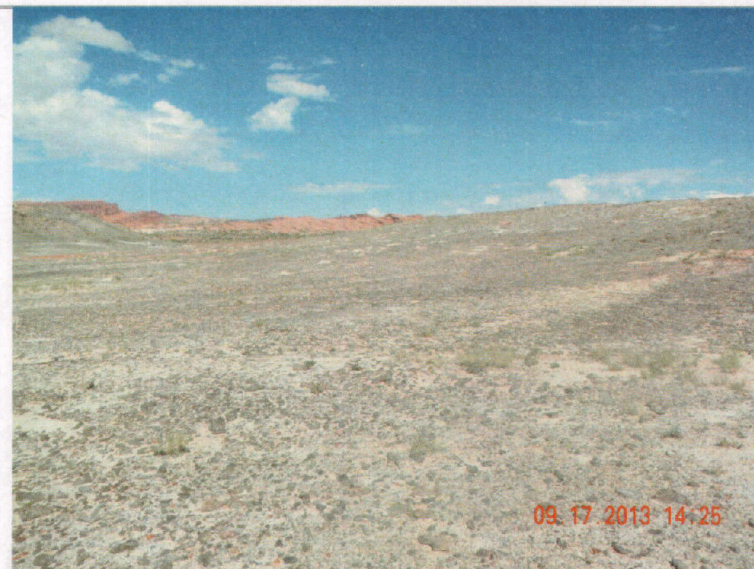
Hole locations along NW-facing slope

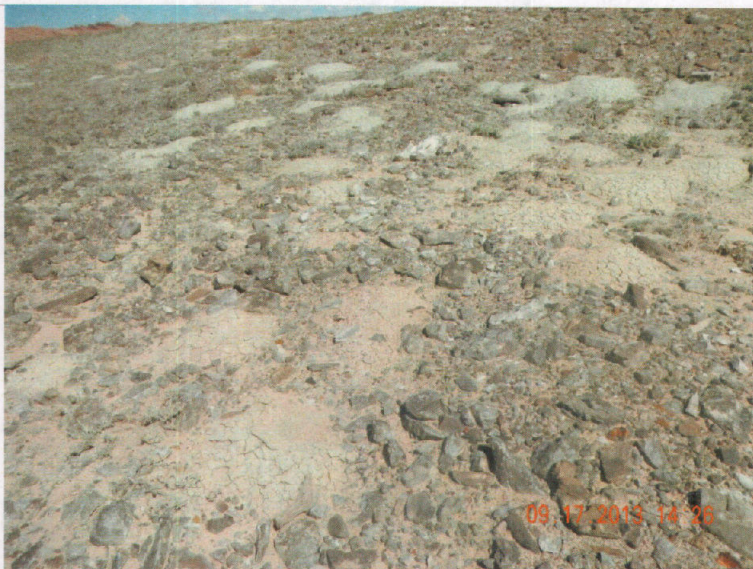
Hole locations on desert pavement

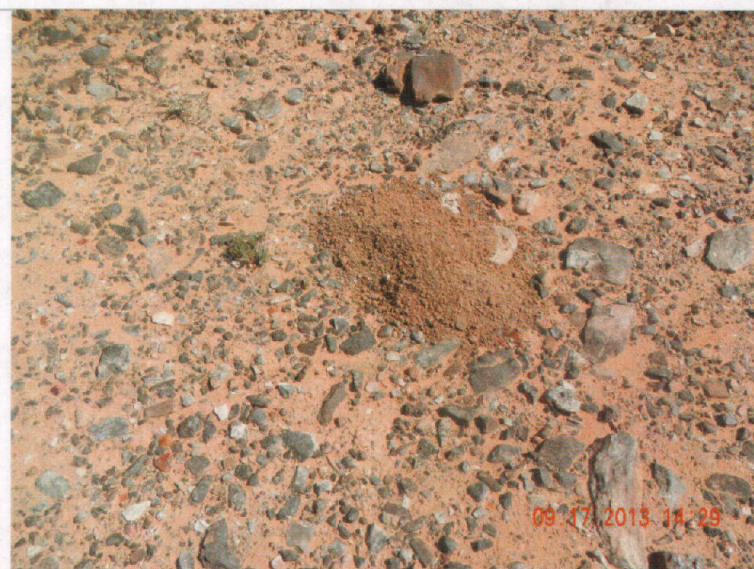
"Fresh" hole location

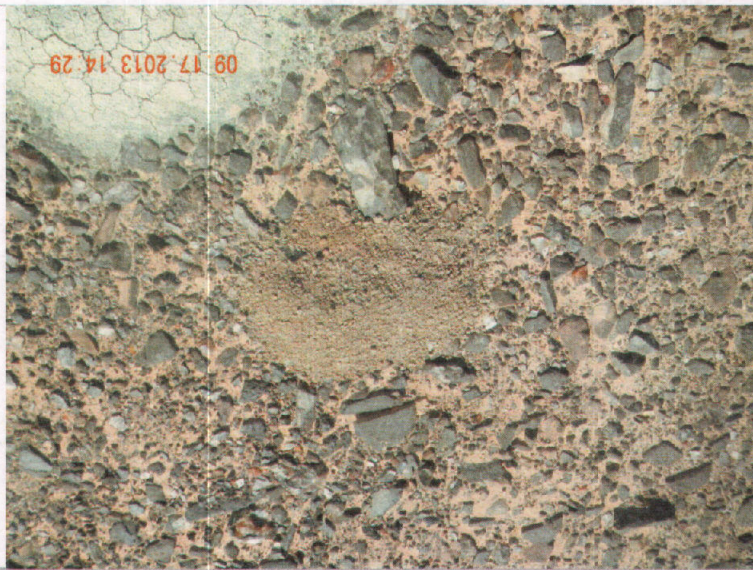
<p>"Fresh" hole location next to older one</p>

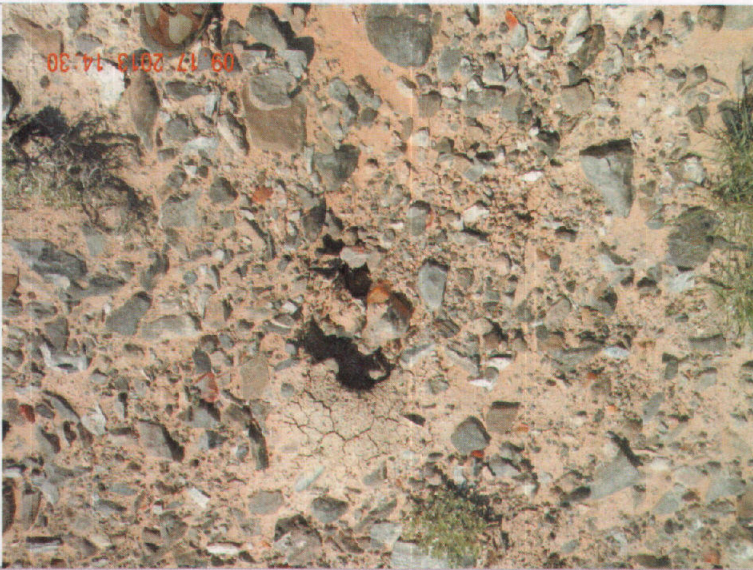
6. <i>Reclamation</i> Looked for any needs for reclamation; found none	<input checked="" type="checkbox"/>	<input type="checkbox"/>
7. <i>Backfilling/Grading (trenches, pits, roads, highwalls, shafts)</i> Found what appeared to be shallow, small-diameter bore or auger holes, all were partially backfilled	<input checked="" type="checkbox"/>	<input type="checkbox"/>

<p>Hole in ground, unknown depth</p>

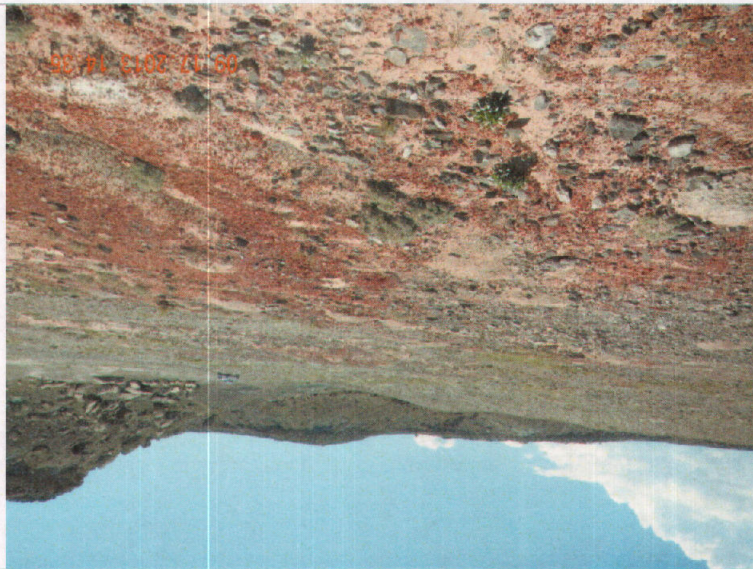
<p>Numerous hole locations along slope</p>

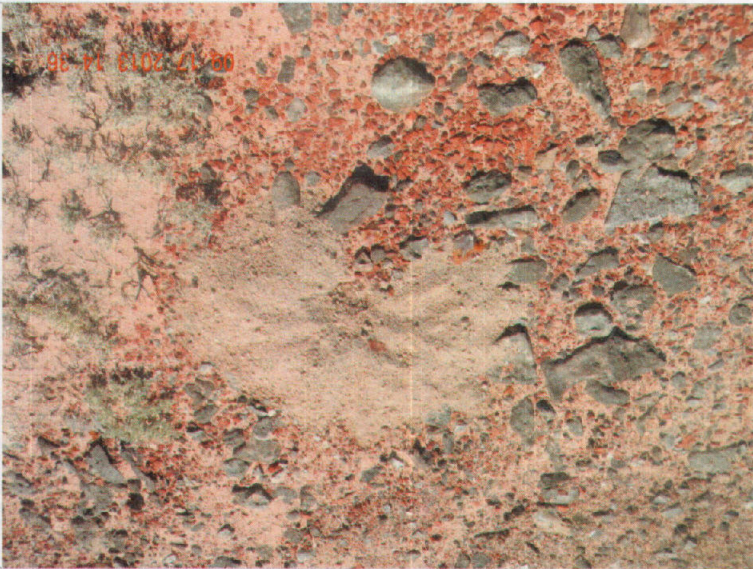
<p>Hole location with appearance of hand-backfilling</p>

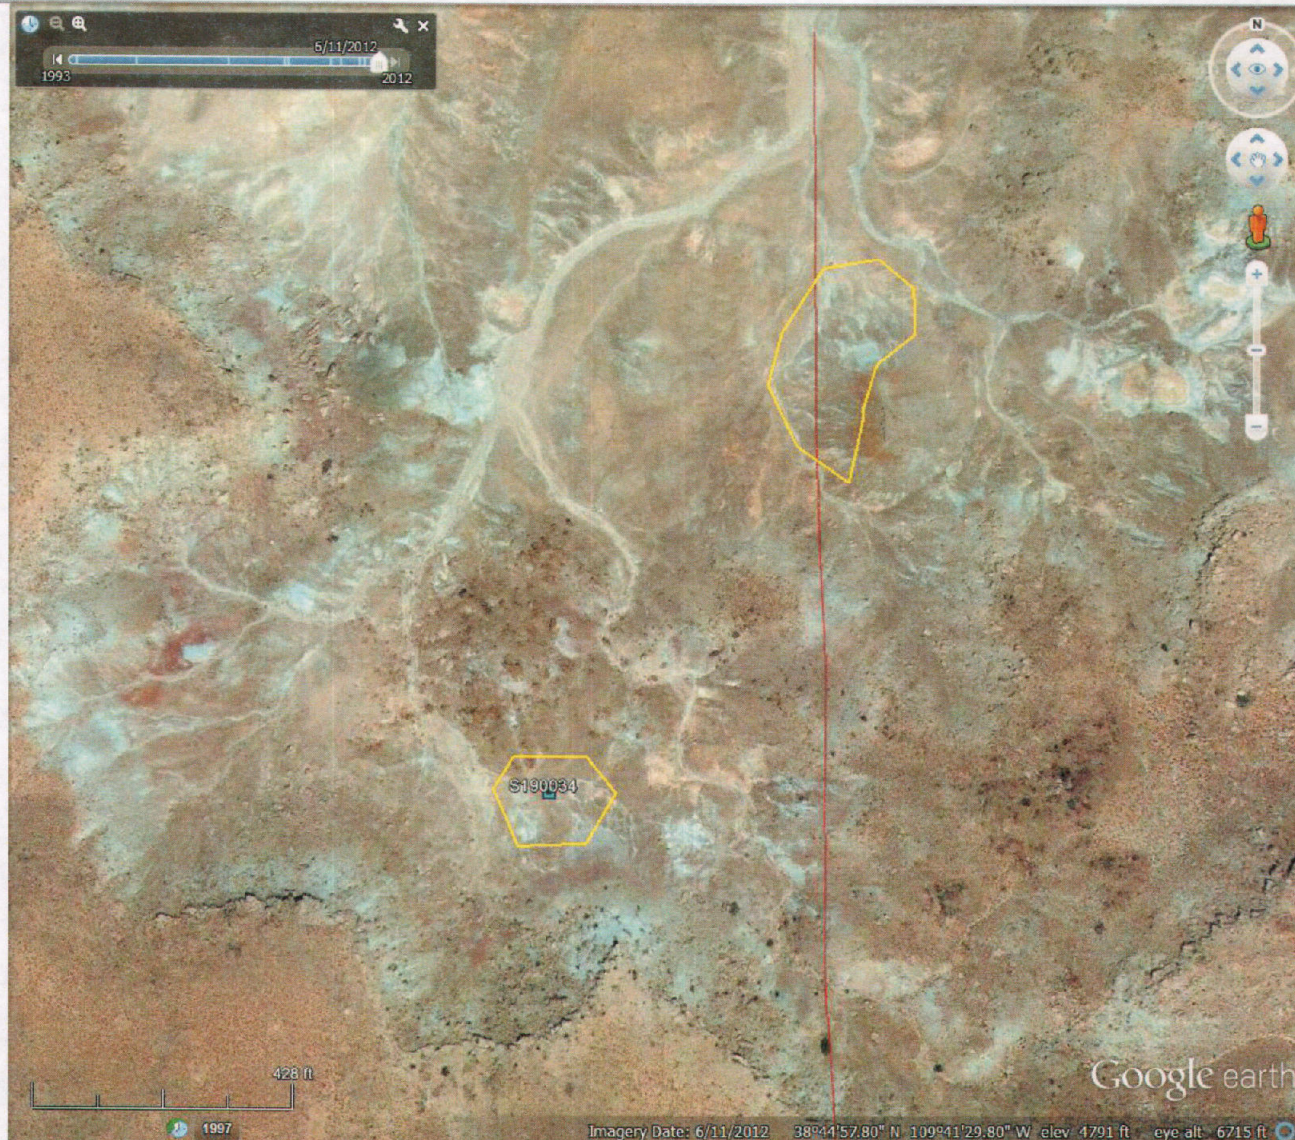
Yellow area to NE was walked this visit; yellow area to SW is believed to be where permit area is.

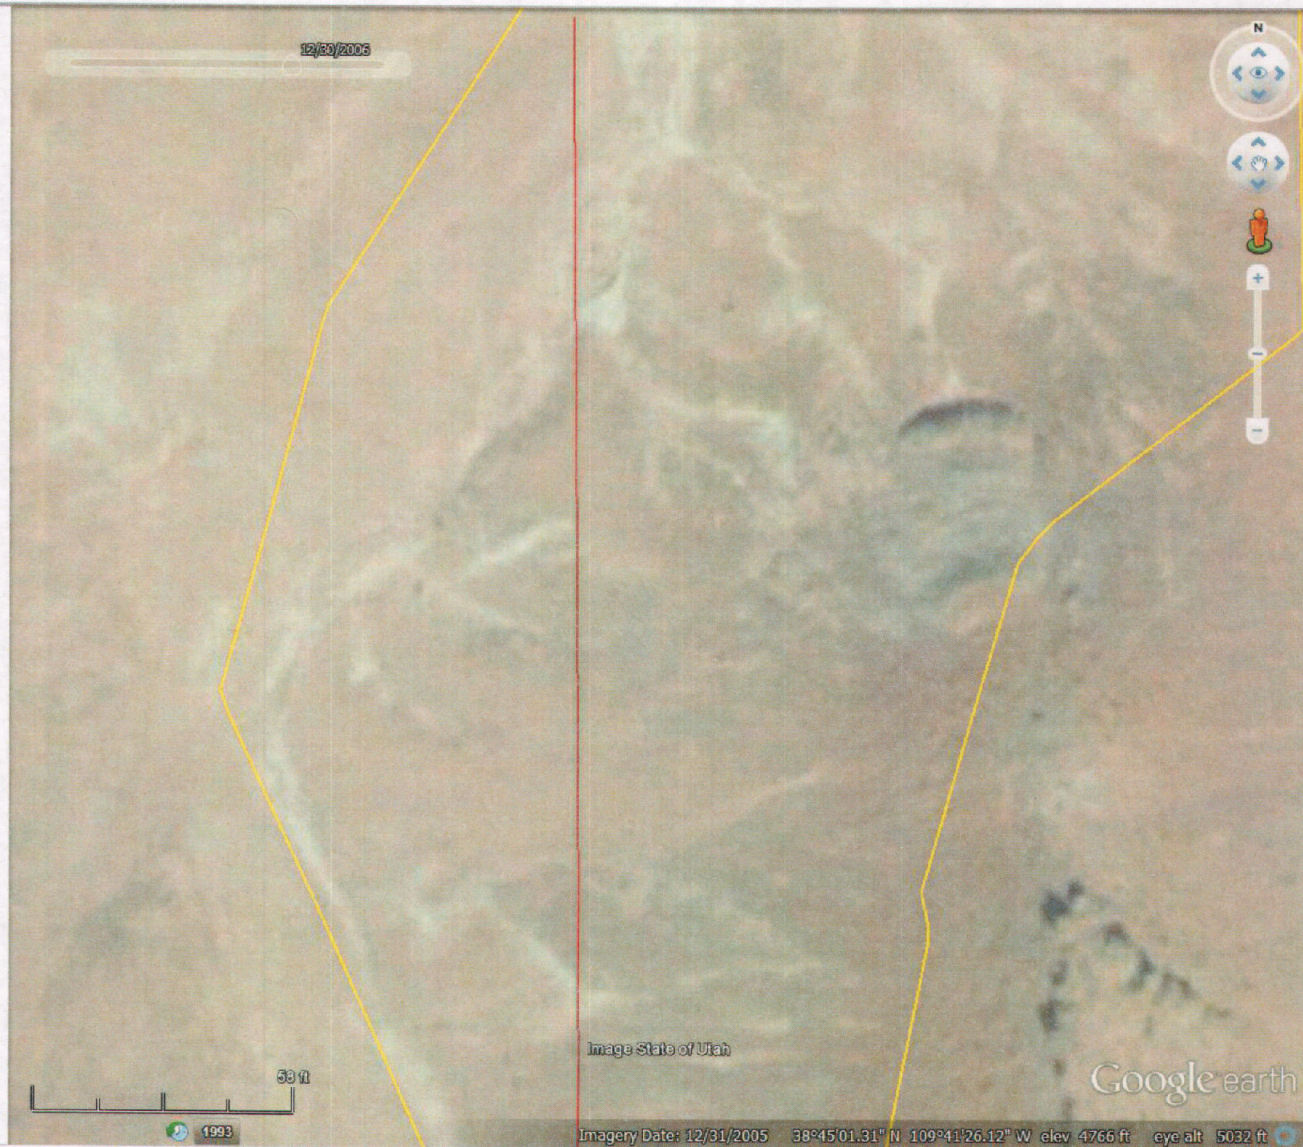
2006 aerial image of area walked this visit with no indications of disturbance

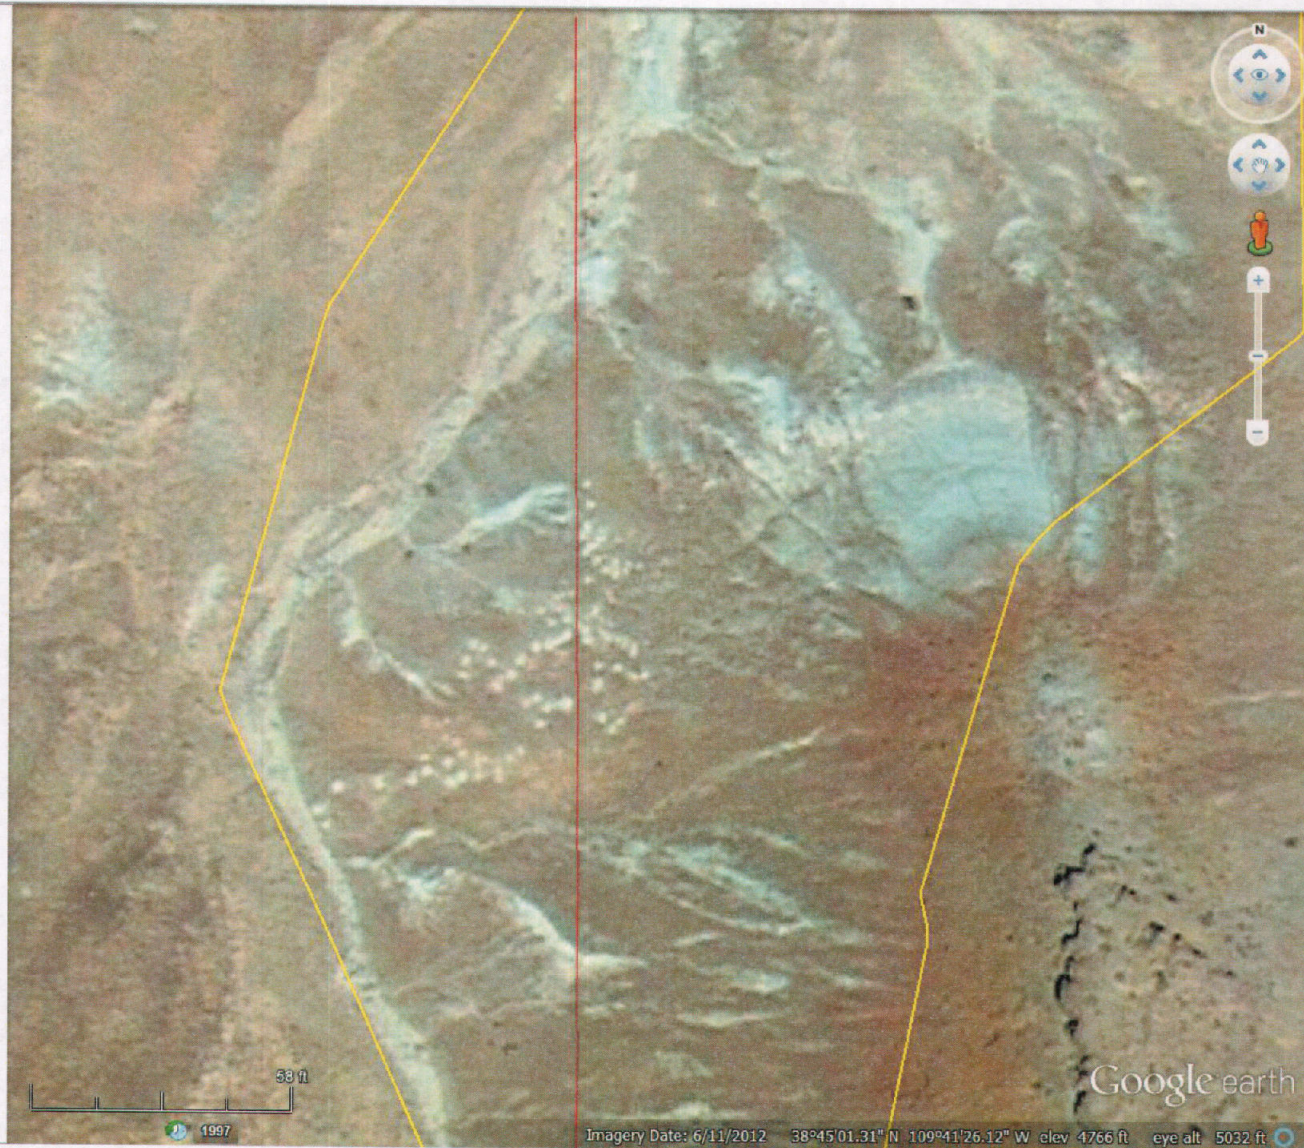
2012 aerial image of area walked this visit with white scars where holes are
